Asentria Product Guide

EventSensor ID

(Revised 11 November 2020)

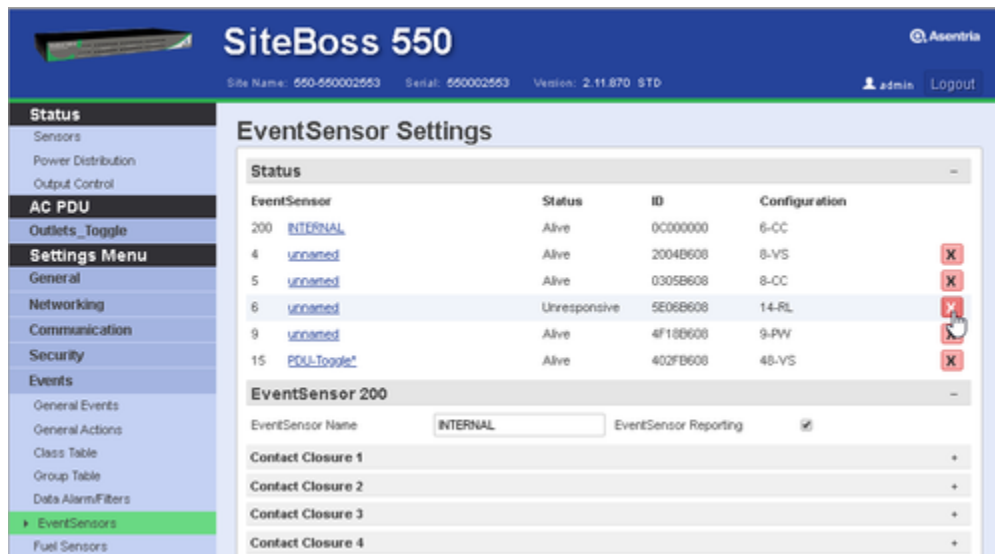
The sensor IDs are associated with the type of unit, so switching to custom firmware or upgrading unit types can create a situation where the unit is not recognizing the slot card. Clearing the EventSensor id should clear the issue.

This issue occasionally happens when downloading settings from another unit with the Sensor IDs in the SK file. We recommend removing the sensor IDs before uploading the sk to a new unit. If an expansion card should go unresponsive after an settings upload the fix is the same.

- 1) Save the non-default settings for the unit using the Administration/System Administration page.
- 2) Clear the affected slots by clicking the red X associated with the unresponsive sensor card

from the Events/EventSensor menu.

- 3) Confirm the 'are you sure' pop up? by clicking OK.
- 4) Restart All from the Administration/System Administration page (or power cycle).
- 5) Once it reboots see if the card is now showing as Alive, and if so, reload your settings using the Administration/System Administration transfer settings to unit option.
